BLM-Alaska Open File Report 64  
BLM/AK/ST-97/022+8111+040  
April 1997

# HISTORIC BUILDING SURVEY REPORT FLAT, ALASKA

by Rolfe G. Buzzell and Darrel L. Lewis

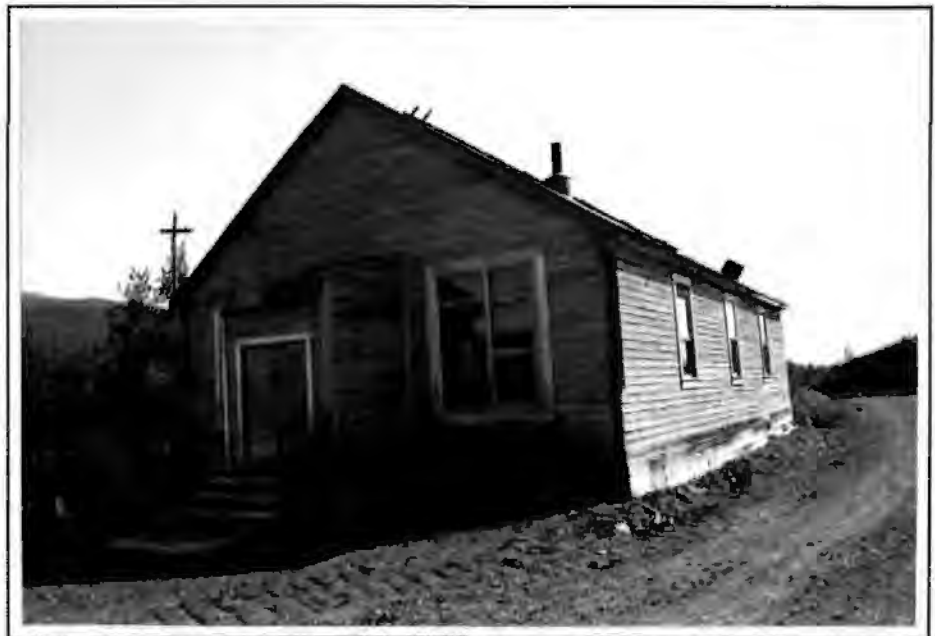
Figure 15. The west and south elevations of the Community Hall, 1993.

The **Community Hall (IDT-070)**, also known as the Moose Hall, is a rectangular, one-story, wood frame building (Figure 15). It measures 30'x47'7". The foundation is stacked wood blocks. The gable roof is felt (tar) paper covered with corrugated metal. Shiplap siding with corner boards covers the exterior walls. An arctic entry with double doors is centered on the west elevation and flanked on each side by a large four-light fixed sash window. The north and south elevations have three evenly spaced 1/1 double-hung windows on each side.

An addition on the east elevation measures 29'7"x23'. It has a gable roof covered with corrugated metal. Two 1/1 double-hung windows are located on the south elevation. Two shed additions are located on the north side of this addition. A five-panel door and a two-light fixed sash window face north. The interior walls of the hall curve into the ceiling.

of 1925 to replace the Moose Hall that was destroyed in the 1924 fire. Unlike the old hall, the Community Hall was built by volunteers. It was located south of the Adams Hotel and was damaged by a flood during the winter of 1942. Residents moved the building to its present location on higher ground during the fall of 1943 (Agoff 1995:217). The building was the focus of community activities, including dances and plays. The one-story addition served as a kitchen and dressing room. It was added before the mid-1930s (Miscovich 1995:I-3-4; Fullerton 1995:120).

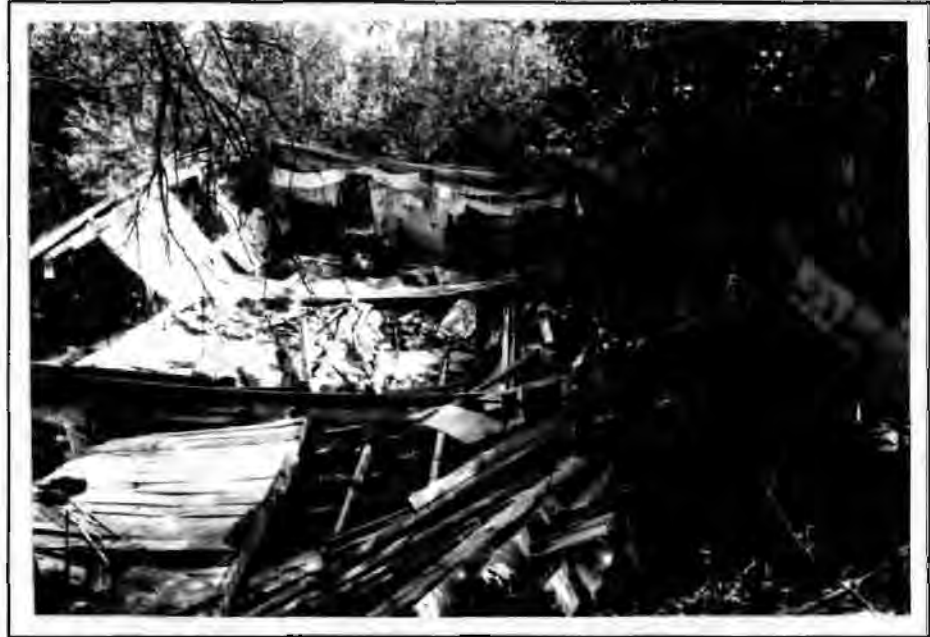
**Figure 16. The ruins of the Andy Miscovich Bar, 1993. The view is looking east.**

The **Andy Miscovich Bar (IDT-071)** is a partially collapsed 2.5 story, rectangular, wood frame building (Figure 16). It measures 22'x45' on the first floor and 22'x34' on the second floor. The siding consists of felt paper. The gable roof has been removed for salvage but scraps of corrugated metal roofing are visible in the debris. The gables, which have collapsed, each contain a window opening. The first floor is built into the side of a hill and the foundation is not visible. The second floor is supported by wood piers. A shed addition is located on the west end of the building and measures 11'x22'. This addition was elevated so that it was even with the second floor. Bar stools, bottles and tables are still visible in the debris. The remains of an addition, measuring 24'x45', are visible on the north side. This was added in 1926 to house a cafe (Miscovich 1995:I,7). Three collapsed wall sections and numerous whiskey barrels are located in the debris.

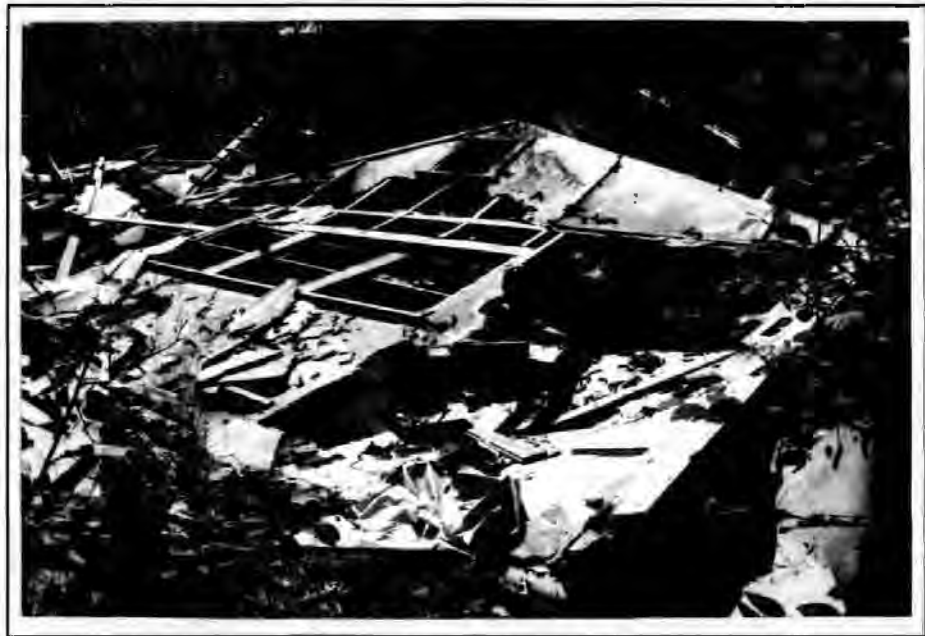
The Durand Restaurant/Parker Bar (IDT-072) is the ruins of a rectangular, 1.5 story, wood frame building (Figure 17). The ruins measures 40'x20'7" and has two additions in ruins on the northeast corner measuring about 17'x 35'. The foundation consisted of wooden posts. Celotex and horizontal boards cover parts of the collapsed walls. Part of the gable roof is located in the ruins. The interior walls were covered with celotex and tongue and groove boards. The main entry faced south and contained a porch. A Diebold Safe and Lock Company safe is located 39'6" southwest of the building.

**Figure 17. The ruins of the Durand Restaurant/Parker Bar, 1993. The view is looking northwest.**

home (IDT-094). Henry Durand sold the restaurant to Charlie Yost in the late 1930s. After the Harry Lawrence and Miscovich bars closed, Joe Parker and Fritz Awe purchased the building and moved it to its present location in 1945. Fritz Awe sold his interest and Parker made good money until 1948, after which many of Flat's old-timers died or moved away. The addition on the northeast corner was a small cafe. Joe Parker died in 1954 and his widow, Stella, abandoned the building (Agoff 1995:214; Miscovich 1995:I-5-6; Fullerton 1995:110).

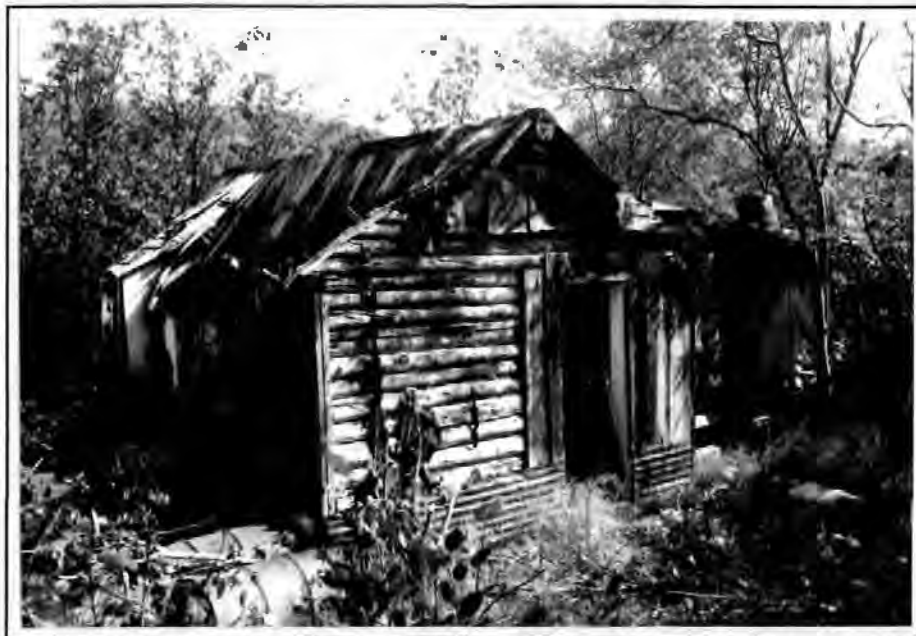
**The Adams Cabin/  
Parker Generator  
Shed (IDT-073)** is a one-story, rectangular, log building with a shed addition on the east side (Figure 18). The building measures 13'x13'6". The foundation is not visible. The partially collapsed gable roof is covered with boards and felt paper. A door opening is located on the south elevation. There is a window opening on the north and west elevations. An east addition measuring 7'10"x

**Figure 18. The Adams Cabin/Parker Generator Shed, 1993. The view is looking northeast.**

13'6" has a shed roof covered with felt paper. There is a five-panel door on the south elevation and a window opening on the north and east elevations. Corrugated metal covers the lower 2' of the exterior. Tar paper over wood planks covers the rest of the exterior. Artifacts in the building include a barber chair, a bench, shelving, a work hench, an electric heater, a cement generator stand, and chemical containers.

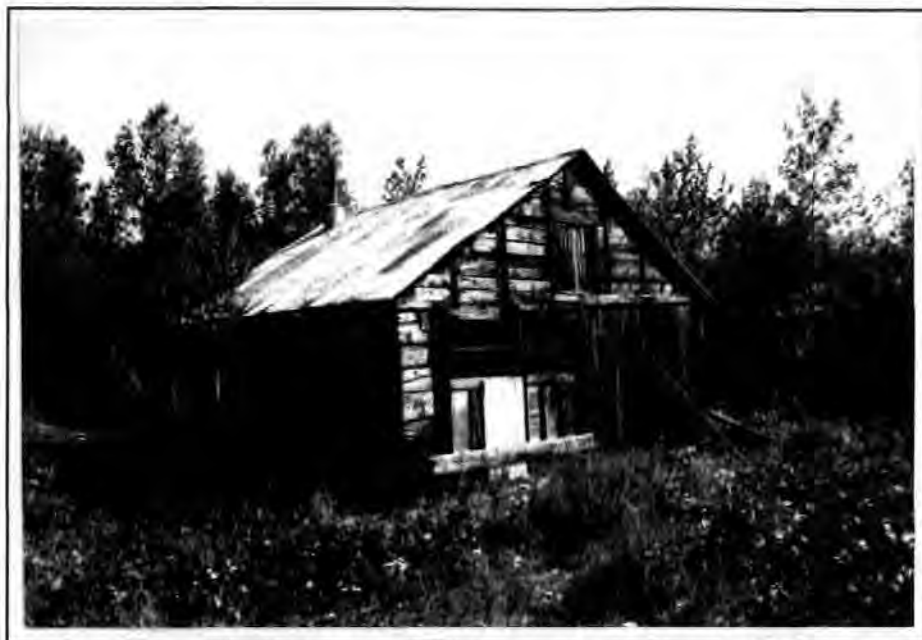
**Figure 19. The Savage/Fullerton Garage, 1993.  
The view is looking northeast.**

**The Savage/Fullerton Garage (IDT-074)** is a square 1.5 story, wood frame building (Figure 19). Each side measures 20'4". The building rests on a timber foundation. The main entrance faces south. The siding consists of felt paper over 1"x8" boards. The gable roof is

covered with corrugated metal. A nine light fixed sash window is located on the north and west elevations and a six-light fixed sash window is located in the north gable. Two sets of large double doors are located in the south elevation and a hay door is centered in the gable. The garage is in good condition. A horse buggy is stored inside the building.

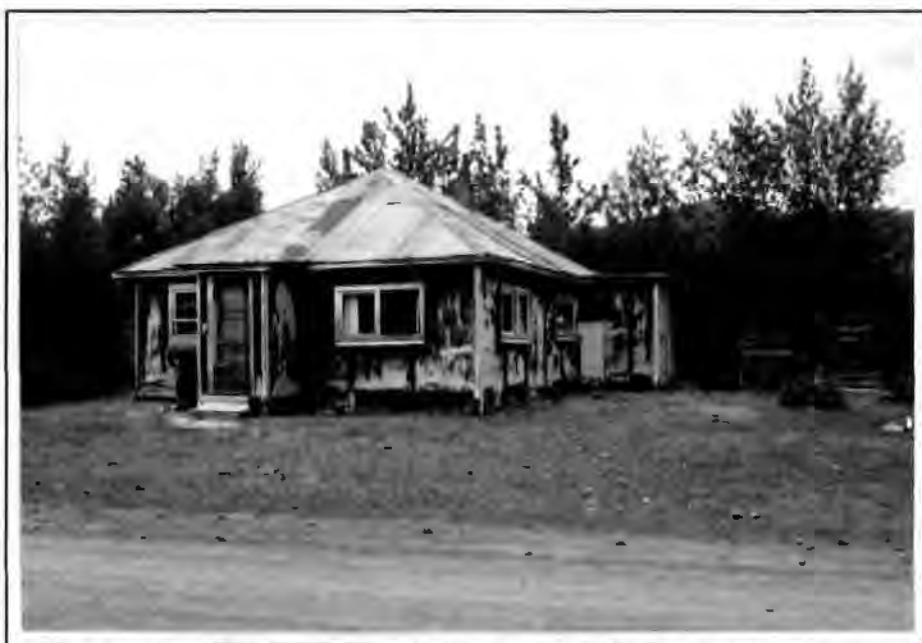
**Figure 20. The Gustafson/Savage/Fullerton House,  
1993. The view is looking northwest.**

The Gustafson/Savage/Fullerton House (IDT-075) is a one-story, rectangular, wood frame building (Figure 20). It measures 20'1"x24'4". The hipped roof is covered with corrugated metal. The foundation consists of short vertical posts. The exterior

siding is celotex. The main entry faces south. A pair of single-light windows is on the east side and a 6/6 double-hung window is on the west side. An arctic entry with a shed roof and three panel door is centered between the windows. The west elevation has a single-light, fixed sash window and a 6/6 double-hung window. The north elevation has a 6/6 single-hung window and two single-light, fixed sash windows. The east elevation has a single-light, fixed sash window, a two-light, fixed sash window, and a 1/1 horizontal single-hung window. An arctic entry measuring 6'1"x 6'2" is located at the north end of the east elevation. The arctic entry has a shed roof covered with corrugated metal and an east facing five-panel door.

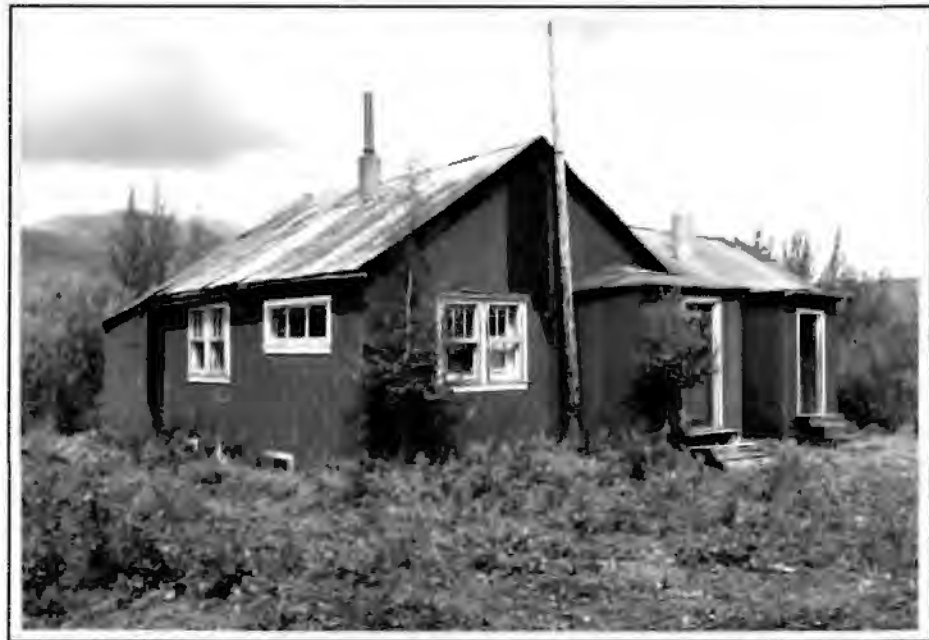
**Figure 21. The Alderson House, 1993.**  
The view is looking northwest.

**The Alderson House and Post Office (IDT-076)** is a 1.5 story, L-shaped, log building (Figure 21). The building has a basement with concrete walls and floor. The exterior siding is green asphalt over felt paper. The oldest part of the house is built of logs, is oriented north-south and measures 20'x32'. It has a gable roof covered with corrugated metal. The south elevation has a pair of 3/1 double-hung windows and an arctic entry.

The arctic entry measures 5'4"x8' and has a hipped roof. A one-panel door with one-light faces south. The west elevation has a three light, fixed sash window and a pair of 3/1 double-hung windows. The east elevation has a two-light, fixed sash window. An addition on the east side measures 12'2"x16'. It has a gable roof covered with corrugated metal. The south elevation

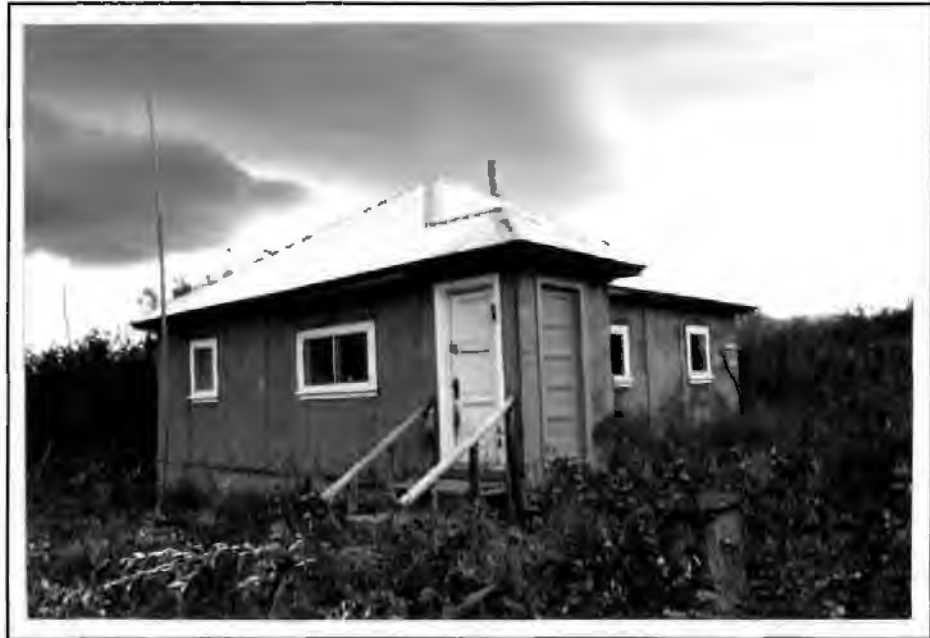
**Figure 22. The Hill/Day/Agoff House, 1993. The view is looking southeast.**

The Hill/Day/Agoff House (IDT-122) is a rectangular, one-story, wood frame building (Figure 22) measuring 24'5"x20'. Corrugated metal covers the hipped roof. The exterior is covered with celotex. The house has three arctic entries with corrugated metal roofs and celotex siding. The main entry faces north and has a single-light, fixed sash window and a two-light, fixed sash window. The west elevation has a single-light, fixed sash window and a two-light, fixed sash window. A hipped roof arctic entry measuring 4'x6' is located on the north end of the west elevation. A three panel door faces north and a five-panel door faces west. A six-light, fixed sash window faces south. The south elevation has a two-light, fixed sash window and a single-light, fixed sash window. A shed roof arctic entry is located on the east end of the south elevation. The arctic entry measures 6'x7' and has a five-panel door facing south and a four-light, fixed sash window facing west. The east elevation has three single-light, fixed sash windows and an arctic entry with a hipped roof. This 4'x4' arctic entry has a three panel door facing north and a single-light, fixed sash window.

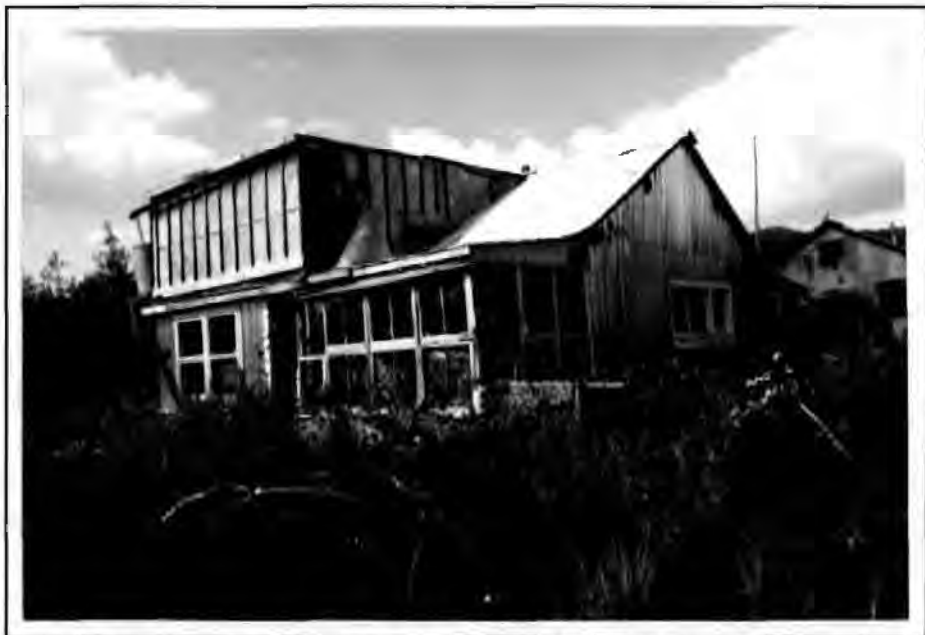
**Figure 23. The Guggenheim Office/Uotila House, 1993. The view is looking northwest.**

The Guggenheim Office/Uotila House (IDT-092) is a rectangular, 1.5 story, log building (Figure 23). The original building measures 22'2"x24'2". The gable roof and log walls are covered with aluminum siding. The east elevation has a triple, two-light, fixed sash window. The west elevation has a single-light, fixed sash window and a pair of single-light, fixed sash windows. A window covered with aluminum siding is located in the west gable. The north elevation has a pair of single-light, fixed sash windows. A 7'9"x14' wood frame addition is located on the west end of the south elevation. The south

elevation of this addition has a full length glass door and a pair of 1/1 double-hung windows. A wood frame greenhouse with a shed roof is located above this addition. The exterior of the green house is covered with clear plastic sheeting. A 7'10"x10' wood frame addition on the east side of the south elevation of the building has a shed roof covered with aluminum. The exterior walls are covered with six 2/2 fixed sash windows and a pair of single-light, fixed sash windows on the south elevation and six 6/6 fixed sash windows on the east elevation. A wood frame shed addition on the north side of the building measures 10'3"x16'2". The roof is covered with aluminum siding. A three panel door with one-light is located on the west elevation. A single-light, fixed sash window and a two-light, fixed sash window are on the north elevation. A two-light, fixed sash window is on the east elevation.

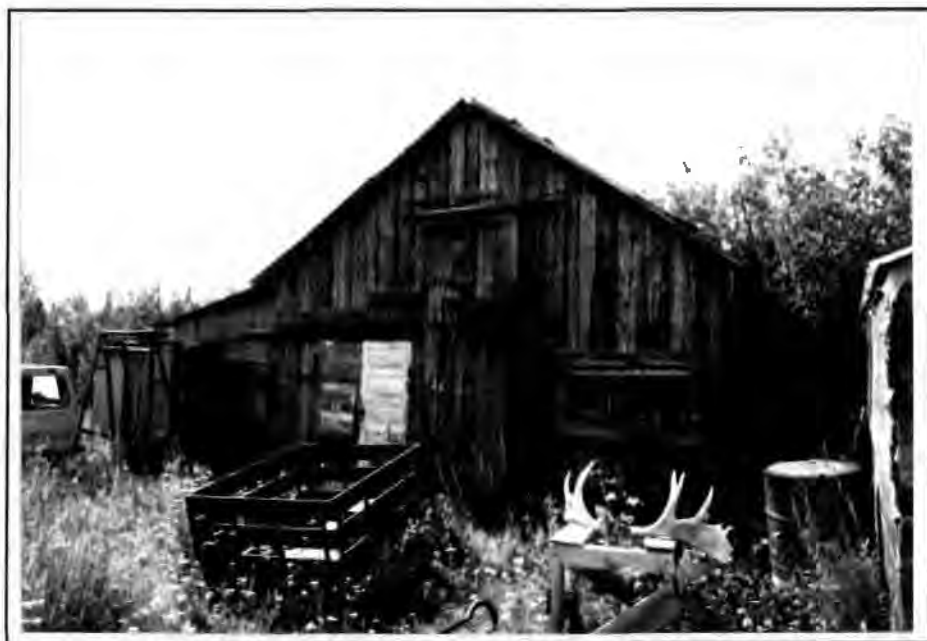
Figure 24. The Miscovich House/Uotila Shop, 1993. The view is looking southwest.

The Miscovich House/Uotila Shop (IDT-243) is a rectangular, 1.5 story building (Figure 24) located about 25' northwest of the Guggenheim Office/Uotila House. The foundation consists of logs. The building is 20' square. It has a gable roof covered with corrugated metal and is sided with vertical lumber. The east

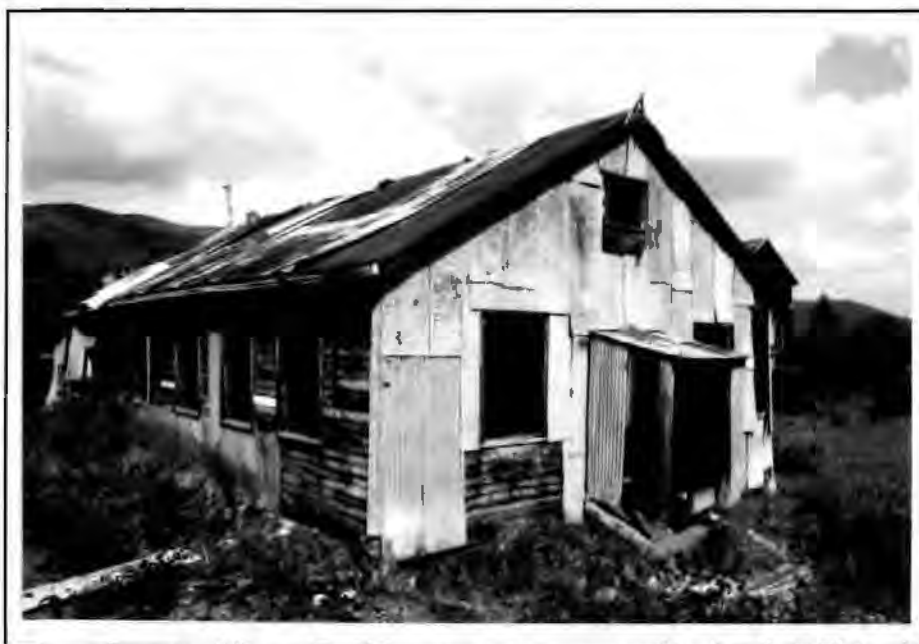
**Figure 25. The Guggenheim Hospital/Schoolhouse, 1993. The view is looking northwest.**

The **Guggenheim Hospital/Schoolhouse (IDT-093)** is a rectangular, 1.5 story, wood frame building (Figure 25) measuring 29'6"x52'9". The foundation consists of horizontal stacked timbers. The

gable roof is covered with corrugated metal. Sections of metal have been stripped away, exposing wood decking. Corrugated metal over shiplap covers the exterior walls. The south elevation has two 1/1, single-hung windows. Between the windows is a shed roof arctic entry, which opens into the classroom. Four 6/6, fixed sash windows are located on the east elevation and five 6/6, fixed sash windows are located on the west elevation. A 6/6 fixed

The Yukon Gold Dredge Company, owned by the Guggenheims, built a hospital in Flat in the early 1910s. The hospital was located west of its current location and north of the Matheson Dredge (IDT-118) near Otter Creek. Dr. Behla was the physician at the hospital in the 1910s. After the Guggenheims left Flat, the hospital was converted into the Otter Territorial School in 1921 or 1922. The building replaced an earlier school that operated in a log cabin. In the spring of 1928, the Schoolhouse was in the path of the Matheson Dredge, so residents moved it to its present location just south of Otter Creek. The school closed in the early 1950s (Bagoy 1995:139; Agoff 1995:208, 210; Fullerton 1995:109; Miscovich 1995:II-18-19, 22).

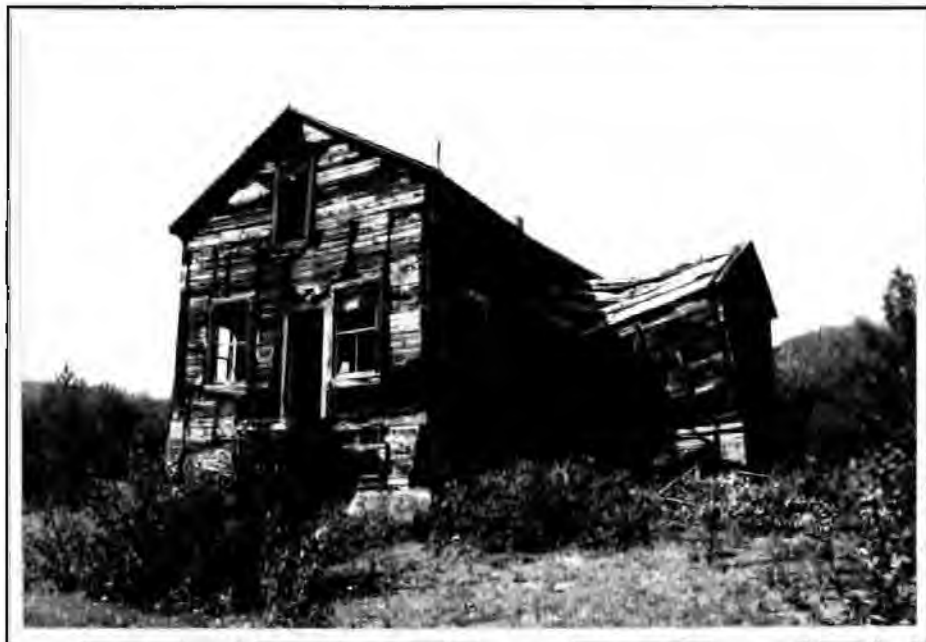
**Figure 26. The Mutchler/Miscovich House, 1993. The view is looking northeast.**

**The Mutchler/  
Miscovich House  
(IDT-094)** is a 1.5 story, rectangular, wood frame building (Figure 26). It measures 21'10"x33'. The foundation consists of 55 gallon steel drums. Weathered felt paper covers the gable roof and exterior walls. Stairs, which are no longer present, rose to an entry centered on the south elevation. A 2/2 single-hung window flanked each side of the door-way. A large window frame is centered in the south

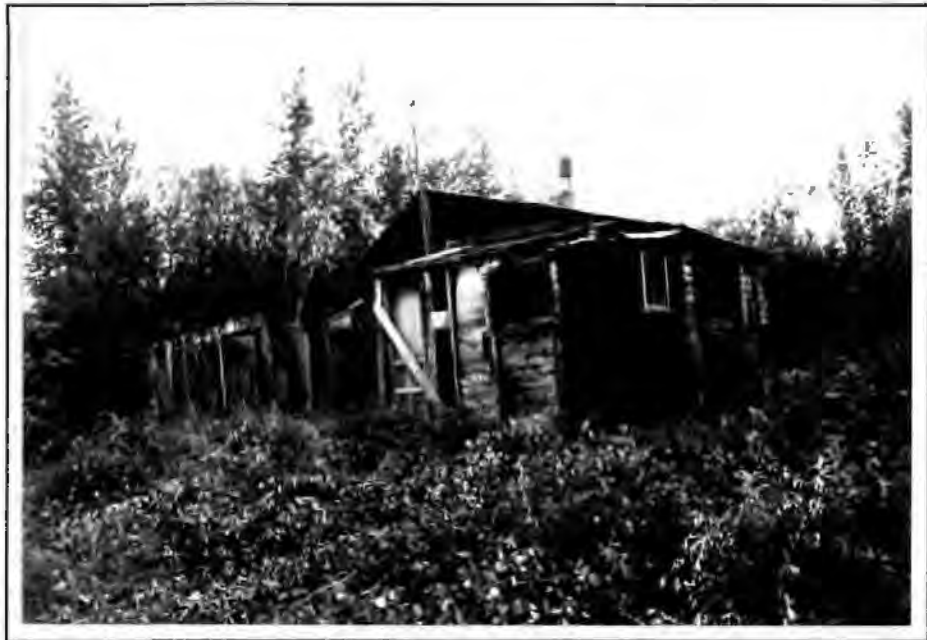
Figure 27. The Michaels/Miscovich House, 1993. The view is looking southeast.

The Michaels/Miscovich House (IDT-095) is a modified rectangular, one-story, wood frame building (Figure 27) measuring 12'x14'2". The foundation is on grade. The gable roof is covered with cor-

rugated metal. Roofing felt over wood siding covers the exterior walls. The main entrance faces north and has a 6/6 double-hung window. The south elevation has a four-light, fixed sash window. A shed roof addition is located on the northwest end of the building. A six-light, fixed sash window is located on the west side and a four-panel door on the east side. An addition on the west side of the house measures 7'3"x14'2". It has a shed roof covered with cor-

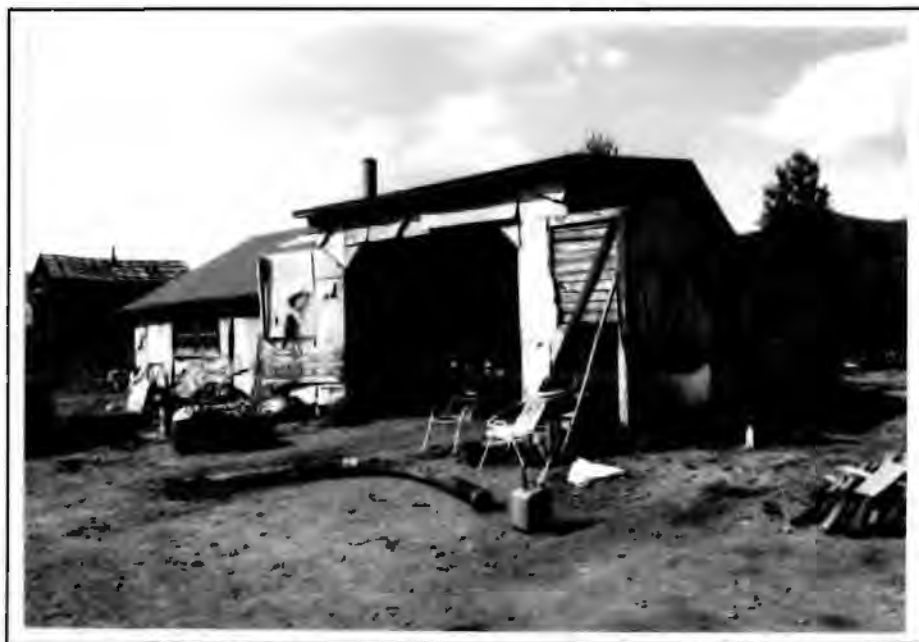
**Figure 28. The Awe/Fullerton Shop, 1993.**  
The view is looking southwest.

The **Awe/Fullerton Shop (IDT-096)** is a one-story, rectangular, wood frame building (Figure 28). It measures 24'2"x40' and rests on grade. The gable roof is covered with roofing felt. Celotex covers the exterior walls. The main entrance faces south and has a pair of six-light, fixed sash windows centered on the west half of the building. The east half of the south elevation has two large utility doors. The southeast quarter of the gable roof is raised to allow access by large vehicles through the utility doors. The west elevation has two large utility doors. The north elevation has a plank door flanked by a single-light, fixed sash window and a six-light, fixed sash window. A 4'x4' concrete foundation (Site Z) is located 27'6" northwest of the Shop Building.

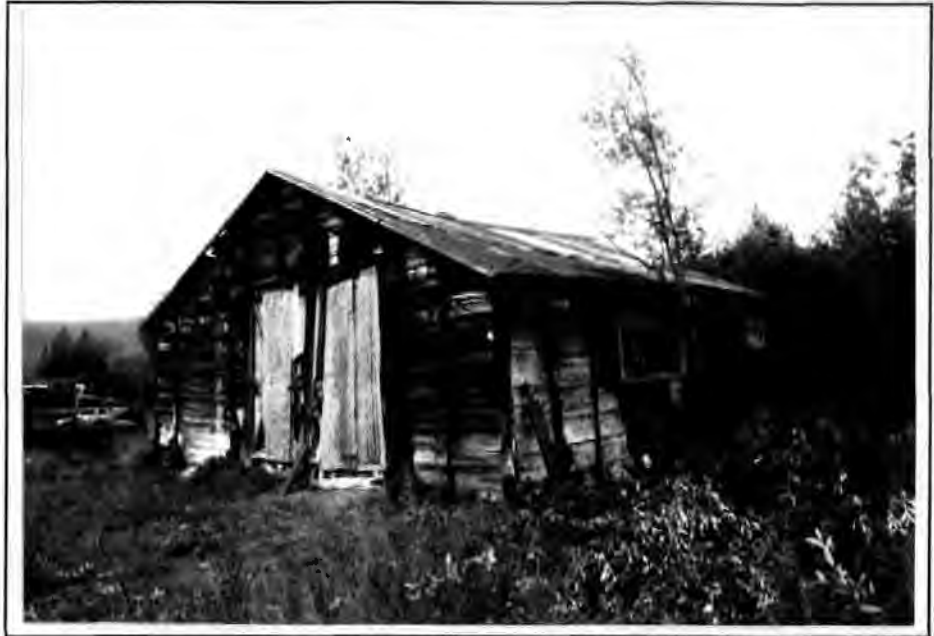
**Figure 29. The Mutchler/Uotila/Fullerton Barn, 1993. The view is looking northwest.**

The **Mutchler/Uotila/Fullerton Barn (IDT-097)** is a rectangular, one-story, wood frame building (Figure 29) measuring 26'1"x27'5". The foundation consists of wood posts on grade. The gable roof is covered with corrugated metal. Weathered roofing felt over tongue and groove siding covers the exterior walls. The main entrance faces south and has two large utility doors just east of center. The east elevation has a pair of six-light, fixed sash windows and another six-light, fixed window. The west elevation has a pair of six-light, fixed windows. The

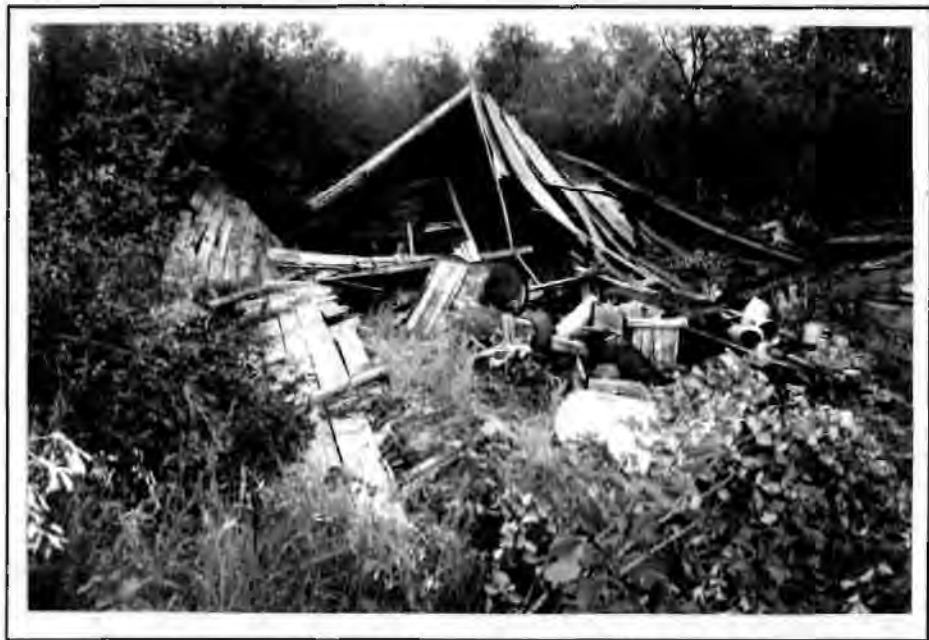
**Figure 30. The Mutchler/Hard/Uotila/Awe Blacksmith Shop, 1993. The view is looking north.**

the ruins of a rectangular, one-story, wood frame building (Figure 30) measuring 17'7"x36'4". The foundation is on grade. The collapsed shed roof was covered with roofing felt over wood decking. The north wall and gable and part of the east wall are standing. Sections of the west wall and the south gable are intact but laying on the ground. The north elevation has a window frame and a plank door. A window frame is located on the north end of the west elevation. A six-light, fixed sash window is located in the south end of the east elevation. The ruins of the south elevation contain a two-panel door with one light. A wood stove is located south of the center of the west side of the building. The ruins contain saddles, crates, auto parts, gas cans and lengths of stove pipe.

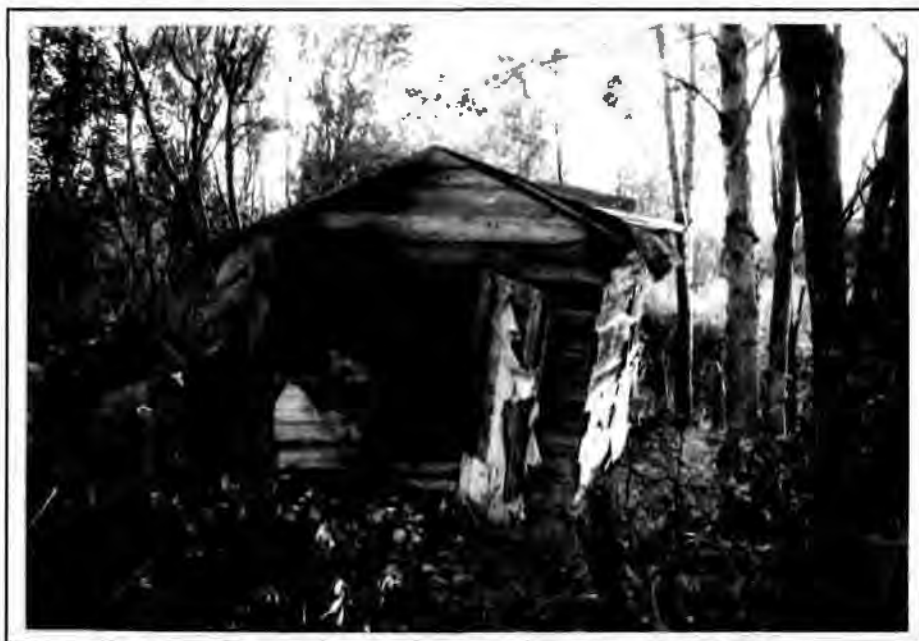
**Figure 31. The DeHouse/Kobler Storage Building, 1993. The view is looking southeast.**

The **DeHouse/Kobler Storage Building (IDT-099)** is a rectangular, one-story, wood frame building (Figure 31) measuring 7'x9'7". The foundation consists of logs and the gable roof is covered with corrugated metal. Weathered roofing felt over wood siding covers the exterior walls. The main entrance faces north and contains a plank door. A four-light, fixed sash window is centered on the west elevation. The roof was sagging in 1993 and the building was in poor condition.

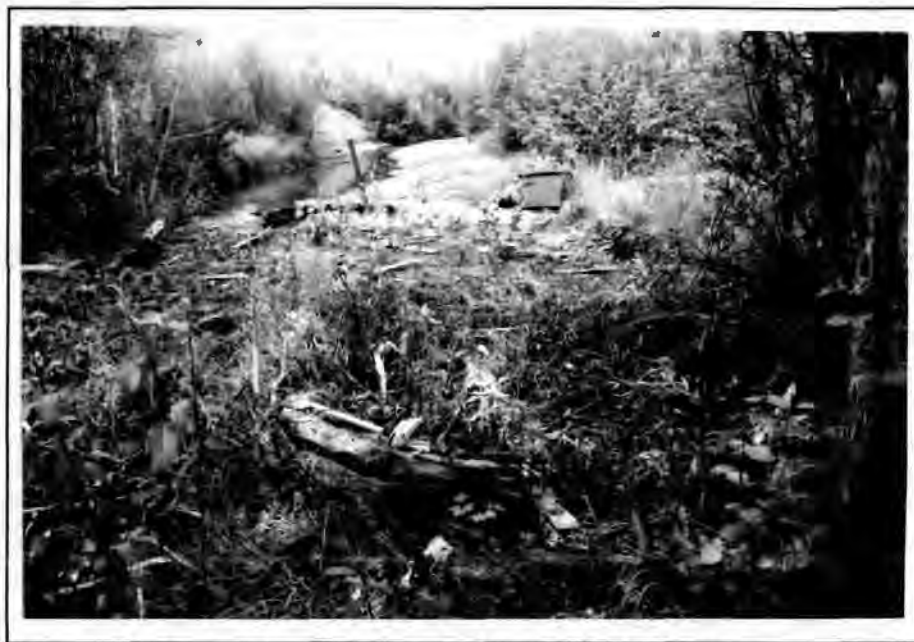
**Figure 32. Ruins of the Uotila/Marcell House, 1993. The view is looking north.**

The **Uotila/Marcell House Ruins (IDT-100)** consists of the remains of a rectangular, two-story wood frame building (Figure 32). The house had a log foundation and measured 15'7"x 22'10". The walls and roof are missing. The floor of an arctic entry is located in the southeast corner and measures 6'7"x7'. A large metal box, possibly a boiler, is located in the northeast corner of the site. A broken porcelain mug is located near the boiler. The northwest corner of the foundation is undercut by Otter Creek. Some shiplap and wood siding are in the debris.

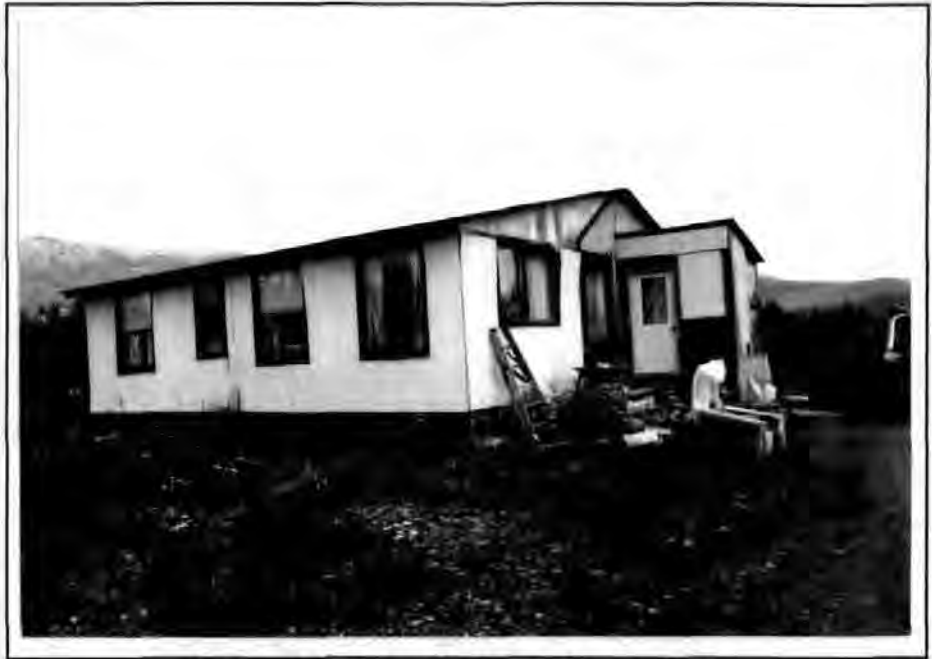
**Figure 33. The Williams House, 1993.**  
The view is looking northeast.

The **Williams House (IDT-101)** is a rectangular, one-story, wood frame building (Figure 33). The east portion measures 15'x46'4" and the west portion measures 18'x32'2". An arctic entry measuring 7'6"x7' is located on the south end of the east section and has a metal door. A gable roof with asphalt shingles covers the entire structure and runs north-south. Plywood and T1-11 cover the exterior walls. All windows are recent metal casement windows. A shed roof addition, measuring 12'x18', is located on the north end of the house. The roof is covered with aluminum siding and the exterior is covered with plywood.

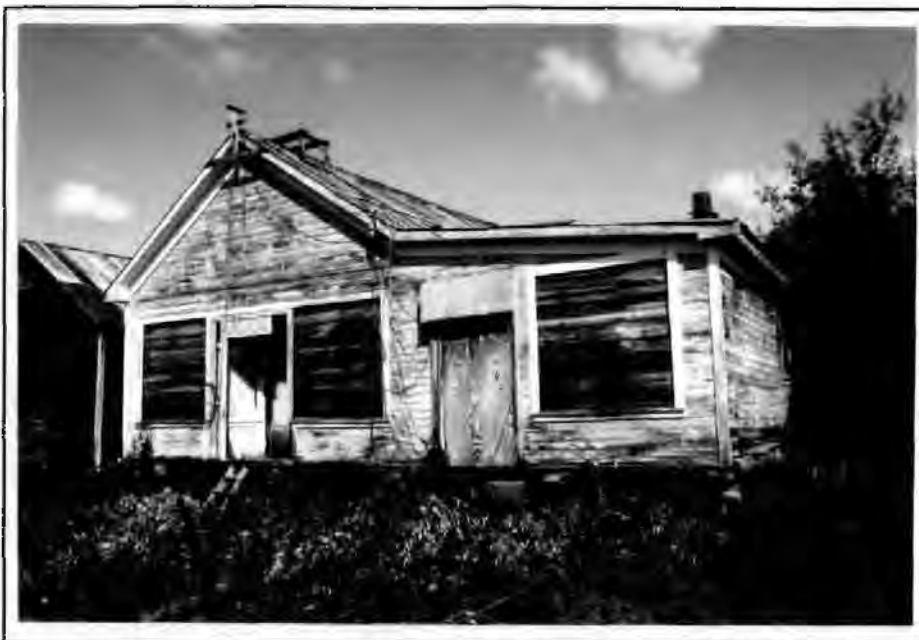
**Figure 35. The Donnelley and Sheppard Store, 1993. The view is looking northeast.**

The Donnelley and Sheppard Store (IDT-077) is a rectangular, one-story, wood frame commercial building (Figure 35). The main portion of the building measures 34'x76'4". The foundation consists of wood blocks. The building has a gable roof covered with corrugated metal. The siding consists of shiplap with corner boards. The main entrance is the west side

of the building. A recessed storefront entry is centered on the east and west elevations. Each entry is flanked by a four-light window that is boarded over. Each recessed entry has a two-light, fixed sash window on each side of the door. The door has a single-light window and a transom window. The outer part of the west entry has a single-light, fixed sash window on the north side and a transom window. The outer door and the

outer door and the south side window are missing. The outer part of the east recessed entry has a single-light, side window on either side of a single-light door and a transom window. The east outer entry way is boarded over. The north elevation has a boarded over window. There are no windows or doors on the south elevation. Decorative elements on the building include awning fixtures and enclosed cornices with returns.

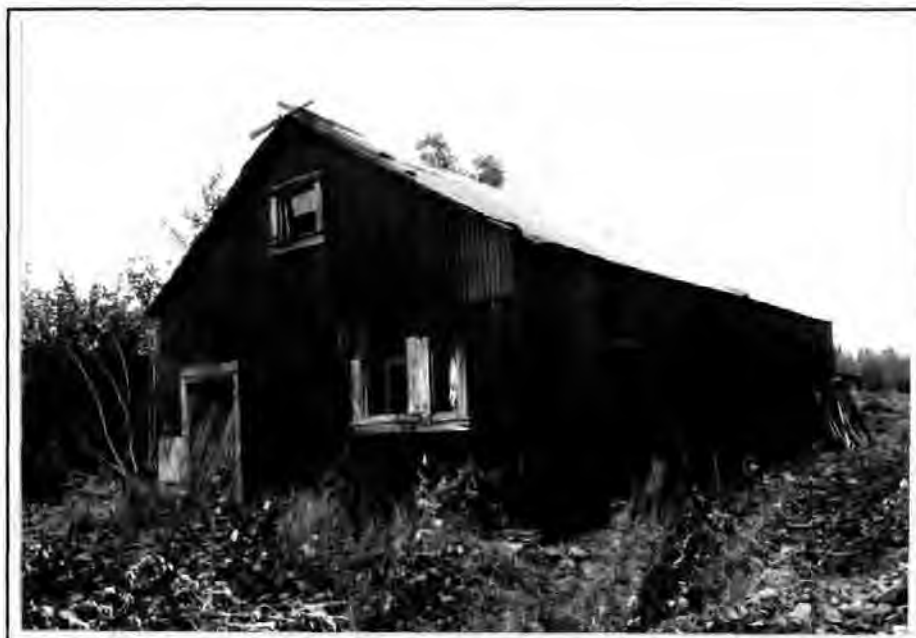
**Figure 36. The Donnelley and Sheppard Cold Storage Building, 1993. The view is looking southwest.**

The **Donnelley and Sheppard Cold Storage Building (IDT-078)** is a rectangular, 1.5 story, wood frame building (Figure 36). The foundation is logs and wood beams. The gable roof and exterior walls are covered with corrugated metal. The building measures 20'3"x52'4". A six-light, awning window is centered in the east and west gables. The east elevation has a large diagonal plank door and a pair of two-light, fixed sash windows. The north elevation has a door opening at the east end. The west elevation has a two-panel door with one-light and a three-light, fixed sash window. A two-light, fixed sash window is located on the west end of the south elevation. Inside the building is a large walk-in refrigerator. The condensers that operate the refrigerator are located in the west end of the building. A hand operated gasoline pump is laying next to the outside wall at the east end of the south elevation.

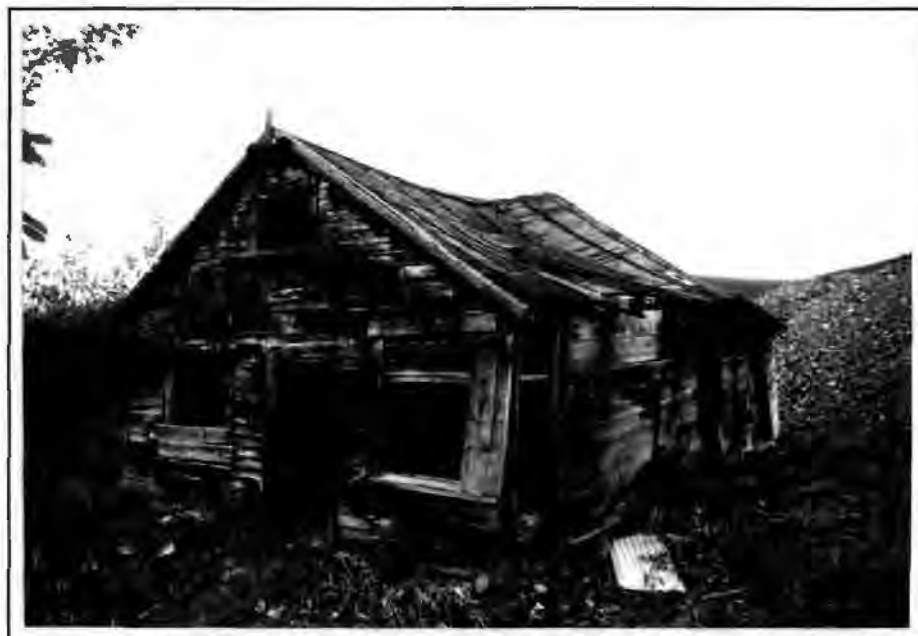
**Figure 37. The Assay Office, 1993.**  
The view is looking northwest.

The **Assay Office (IDT-079)** is a rectangular, 1.5 story, wood frame building (Figure 37). The building is 20' square and the foundation is on grade. The gable roof is covered with roofing felt over wood decking. The exterior is covered with roofing felt over shiplap. The main entrance faces south and has a five-panel door flanked on each side by a large window opening. A six-light, fixed sash window is centered in the north and south gables. A two-light, fixed sash window is located in the south end of the east elevation. The west elevation has two boarded up windows. A shed addition measuring 12'x20' is located on the north side of the building. The roof and exterior siding of the addition are the same as the rest of the building.

The north elevation has a three panel door with one-light and a four-light, fixed sash window. The east elevation has a boarded up doorway. The west elevation has a window opening with no frame or lights. The interior of the building contains building debris, furniture and a number of containers with chemicals associated with assaying. The building is in poor condition. An outhouse measuring 4'2" x 4'7" is located 15'6" southwest of the Assay Office. The outhouse has a shed roof and walls covered with corrugated metal over wood siding.

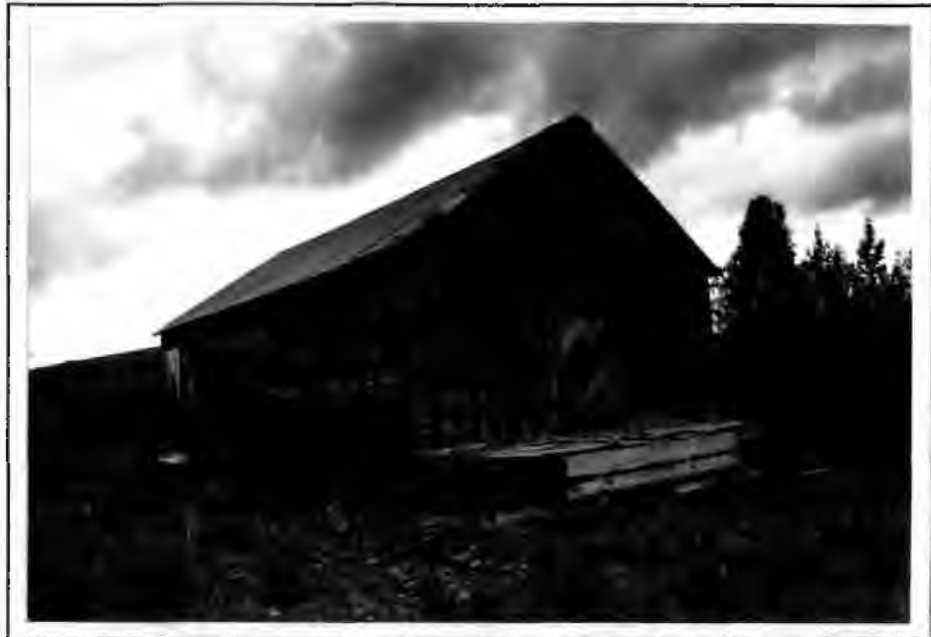
**Figure 38. The Turner/Donnelley Hardware Building, 1993, The view is looking northwest.**

The Turner/Donnelley Hardware Building (IDT-080) is a rectangular, one-story, wood frame building (Figure 38). It measures 24'x40' and the foundation consists of wood blocks. The gable roof is covered with corrugated metal. Shiplap covers the exterior walls. The main entrance faces east and a large plank door in the center opens onto a 5'6" x 18'10" loading dock. A screen window is above the door. The west elevation has a boarded up doorway and a six-light, fixed sash window.

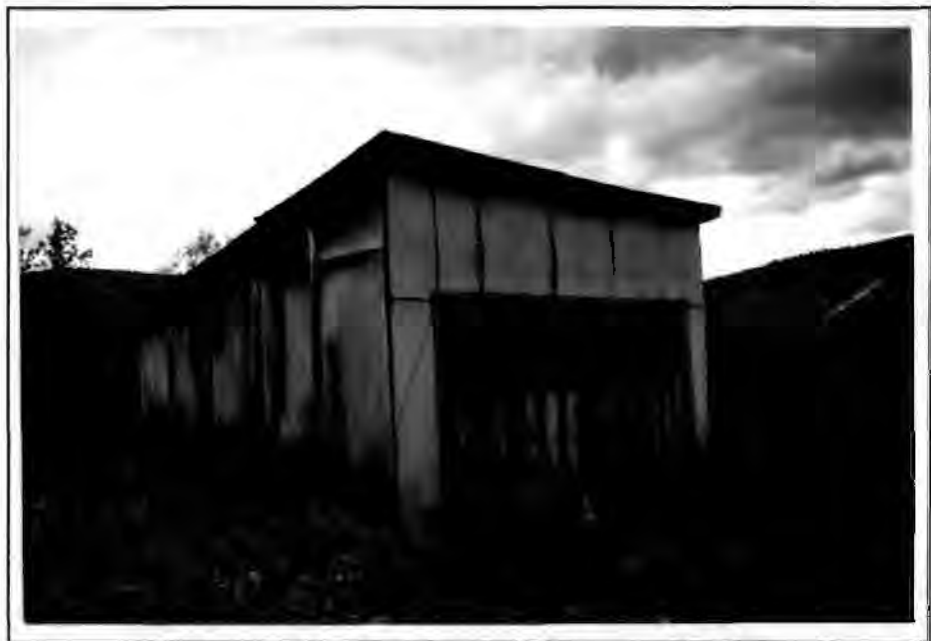
**Figure 39. The Donnelley Garage, 1993. The view is looking northwest.**

The **Donnelley Garage (IDT-081)** is a square, one-story, wood frame building (Figure 39) measuring 20' on each side. The foundation consists of beams. The shed roof is covered with corrugated metal. Celotex siding covers the exterior walls. The main entrance faces east and has two pairs of large utility doors. Each door contains three panels and a six-light, fixed sash window.

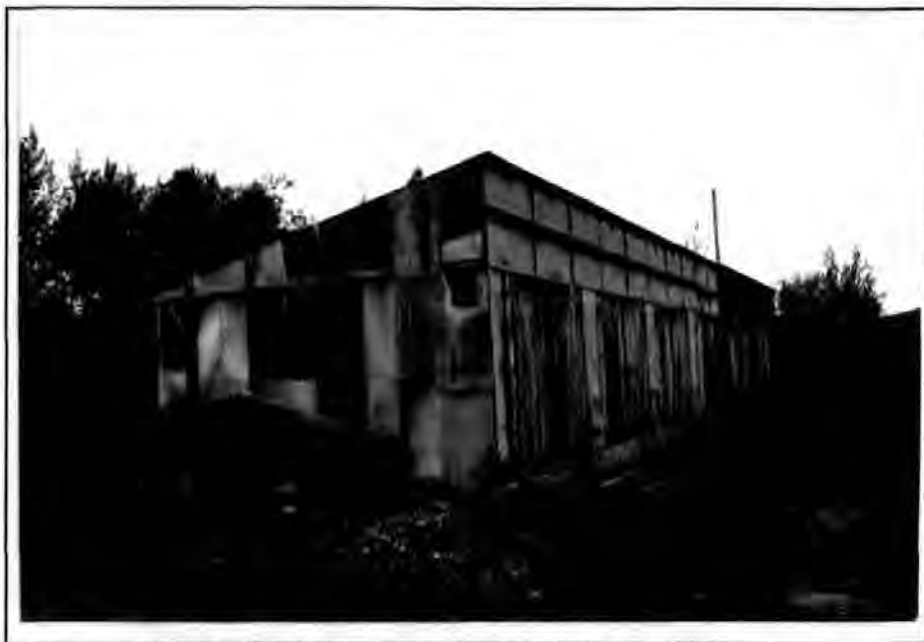
**Figure 40. The Donnelley Lumber Warehouse, 1993. The view is looking southwest.**

The **Donnelley Lumber Warehouse (IDT-082)** is a rectangular, one-story, wood frame building (Figure 40). The foundation consists of logs and wood beams.

The shed roof is covered with corrugated metal. The building measures 19'x40'. Celotex covers the exterior walls although portions of the south and west wall covering is missing. Corrugated metal covers some of those missing wall sections. The main entrance faces north

and contains four pairs of large plank doors. A shed roof addition on the west side measures 24'3"x29'8". The roof and walls are covered with the same materials as the rest of the warehouse. The addition has two pairs of large plank doors. A pair of window openings without glass are located above one of the sets of doors. The building has a dirt floor.

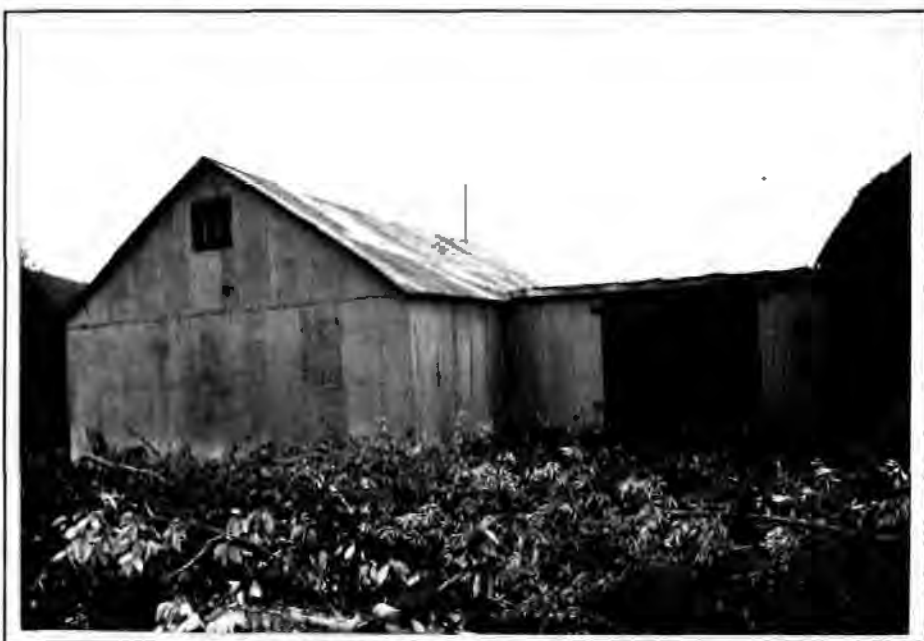
**Figure 41. The Donnelley Pipe Warehouse, 1993. The view is looking northeast.**

**The Donnelley Pipe Warehouse (IDT-083)** is a 1.5 story, rectangular building (Figure 41). The gable roof and exterior walls are covered with corrugated metal. The foundation is logs and wood beams. The building measures 22'3"x35'. A six-light, fixed sash window is centered in the west gable. A pipe rack with a shed roof is located on the east side of the building.

The pipe rack measures 11'2"x17'6". The shed roof is covered with corrugated metal. Access to the building is through an 8'x19'5" addition on the south side of the Pipe Warehouse. The addition connects the warehouse with the Donnelley/Standard Oil Warehouse (IDT-084). The north-south gable roof and exterior walls of the addition are covered with corrugated metal. The west elevation has a set of plank doors. The east elevation has a plank door and a four-light, fixed sash window.
